**TECHNICAL REPORT**  
**TR-NAVFAC-EXWC-PW-1406**  
**APRIL 2014**

**BUILDING INTEGRATED PHOTOVOLTAIC (PV)  
ROOFS FOR SUSTAINABILITY AND ENERGY  
EFFICIENCY**

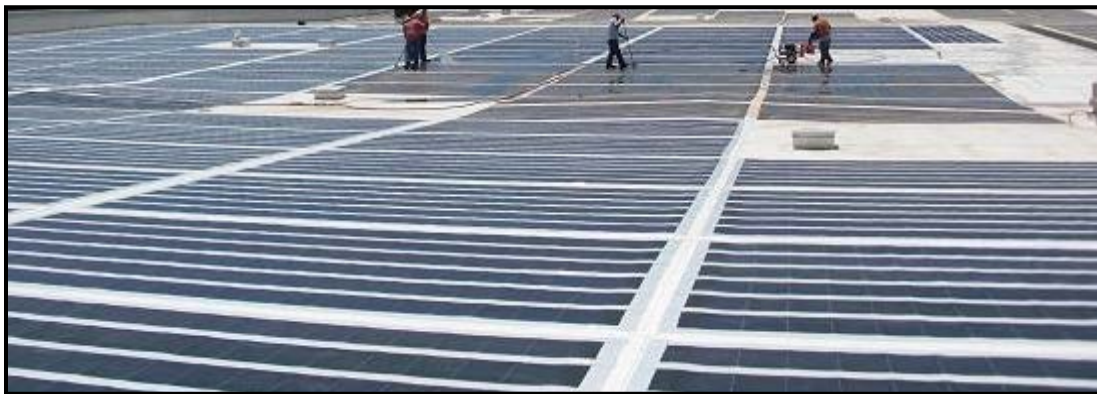
**Figure-5: Luke AFB BIPV roof being cleaned during adhesive-failure fix.**

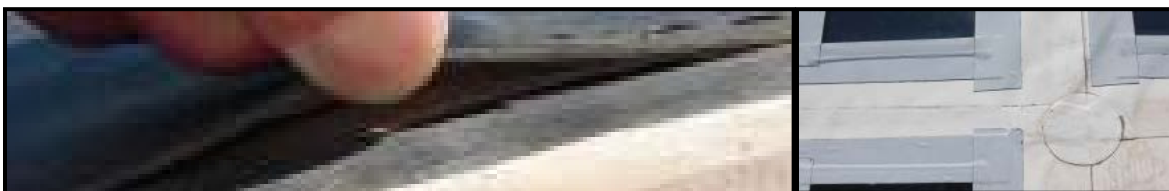
The left photo in Figure-13 shows the bond failure between the PV and PVC carrier sheet. Since the PVC carrier sheet may still provide for a water tight roof assembly, problems experienced by the PV modules may not impact ROOFER scoring. In response to the bond failure, the PV manufacturer taped the frame around the PV to the adjacent PVC membrane in an attempt repair the problem in May 2010 (Figure-15, right). Unfortunately, some of the tape deteriorated less than six months after it was applied. The deteriorated tape exposed adhesive residue, which collected dirt and reduced the overall reflectivity. Figure-14 shows some of the tape deterioration along with soiling of the PV modules. The significant soiling was a result of the low-slope

surface, which does not allow for all the water to completely leave the area and causes any dirt trapped by the water to settle on the roof after the water evaporates. The soiling on the PV modules will reduce the overall roof reflectivity and the energy output of the PV system.

**Figure-13: Bonding failure (left) and tape solution (right) between PVL and PVC at Site I (Luke AFB).**

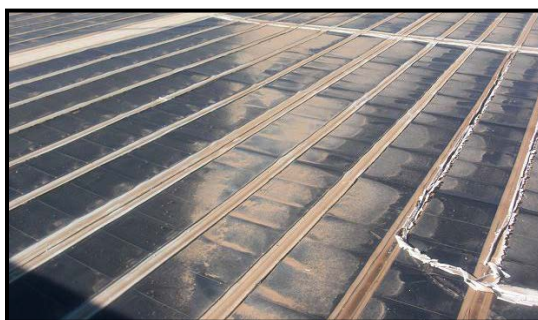
**Figure-14: Tape deterioration and soiling of the PV system at Site I (Luke AFB).**

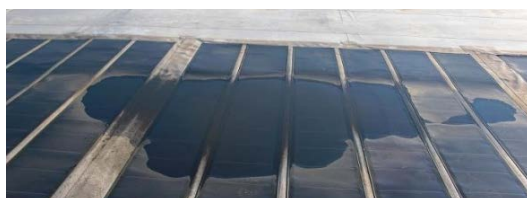
**Figure-17: Site II (NAS Patuxent River) water ponding.**

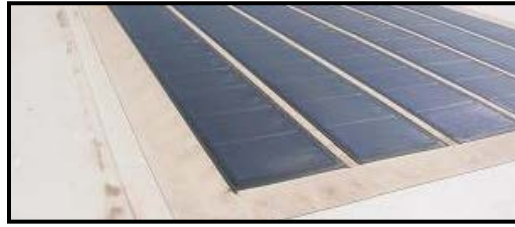
Site III (MCAS Yuma) ROOFER “w/ patch” indices are a result of the PVC samples taken for the tests discussed later (Table-6). ROOFER treats the patch as repair work. For fairness, indices without the patch were generated. The lowered FCI value was due to flashing height not meeting the six-inch requirement, which is needed to reduce the risk of water penetration. Reflectance results are shown in Table-7. October 2011 values were not attained due to the unexpected removal of the ladder needed to safely transport the instrument. However, visual inspections indicated that the soiling had decreased by Oct. 2011. This determination is further supported by the PV conversion efficiency analysis that is presented in the next section. Despite the soiling, the Site III (MCAS Yuma) BIPV roof appeared to have aged well (Figure-20).

**Figure-20: Photo of Site III (MCAS Yuma) in October 2011, 16 months after installation.****Table-8: Notable results from select ASTM D-4434 tests used to evaluate PVC membranes. MD stands for tests in the machine direction and XMD stands for tests in the cross machine direction.**

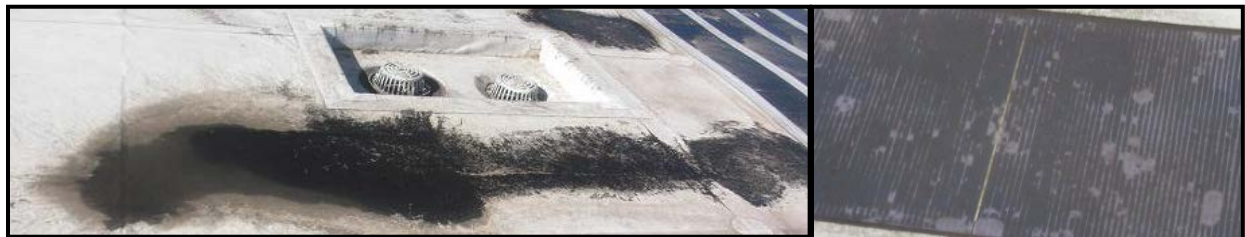
Qualitative inspections of other BIPV roofs similar to those in this study were made. This type of BIPV roof endured well in some areas and some of the notable deficiencies were due to poor construction and practices. In one location, the tape solution prevented water drainage. That same system also experienced significant mold growth due to its tropical environment. Another system experienced localized mold growth due to water ponding (Figure-21, left). The right photo in Figure-21 shows discoloration indicating that the encapsulation of the PV laminate has been compromised. This occurred only in areas where there was significant water ponding, but it is possible that the damage was actually due to snow build-up and the exposure of the encapsulation to freezing temperatures. Interestingly, the tape solution appeared to be unaffected.

**Figure-21: Severe, localized mold growth due to water ponding (left) and PV delamination (right).**

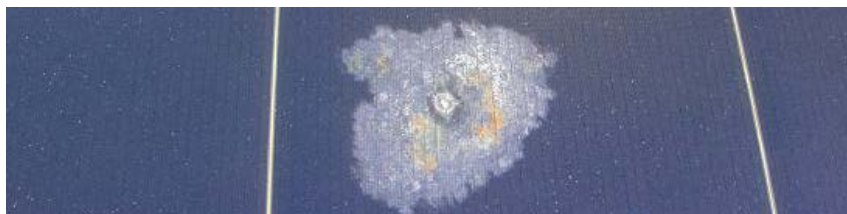
Site II (NAS Patuxent River) did require some maintenance due to a pin-size hole in the PV, but there was difficulty in finding local personnel to perform the maintenance due to the need to operate a small flame to patch the hole (Figure-23). Corrosion is expected to spread to the rest of the cell. Fortunately, the PVL includes bypass diodes connected across each cell, which allows the rest of the cells in the PVL to continue to produce power. The mold growth that was shown earlier is also a concern, but as it was stated earlier, an attempt to remove the mold will likely cause more damage to the roof. The only way to stop additional mold growth is to keep the roof dry, which is impractical, so the only remaining practical course of action is to ensure that the roof remains water tight, such as by surveying the roof every one-to-two years, and replacing the roof at its end of life. The tape solution was not applied to this site due to the lack of the PV bonding problem and the desire to study the BIPV roof as it was originally designed.

**Figure-23: Corrosion of PV material due to a pin-size hole at Site II (NAS Patuxent River).**
